FORM & FUNCTION

Sounds of silence in Nashville

In May 2010, 356 mm (14 in.) of rain caused flooding in Nashville, Tennessee. The recently completed Schermerhorn Symphony Center lost not only its instruments, but also its mechanical systems in the basement. With a time constraint of seven months, knock-down air-handlers were chosen to meet the challenges for access, space-saving, and acoustics.

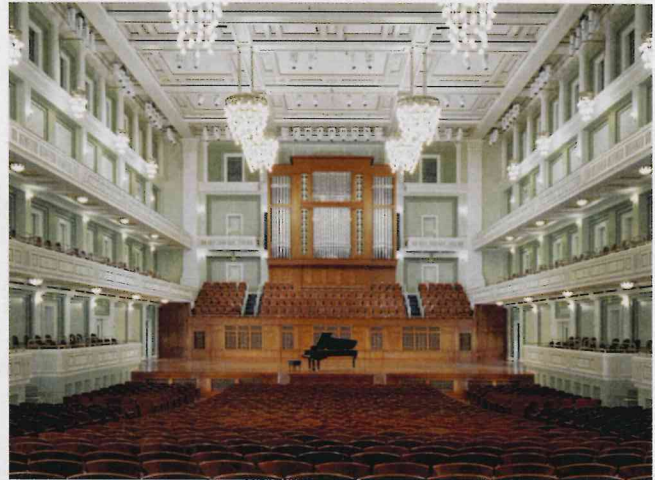
Above: Since most of the flood damage occurred in the basement and ruined the mechanical systems, the Schermerhorn Symphony Center had to replace the air-handlers using modular units.

Home of the Nashville Symphony, the 18,302-m² (197,000-sf), 1844-seat building suffered about \$40 million in damages—from cleanup and reconstruction to lost business. Most was in the basement and sub-basement as the water's force cracked the floor when it filled with 6.7 m (22 ft) of water overnight. The water completely submerged 10 of the 11 air-handling units (AHUs), which were custom-designed to provide efficient airflow at the lowest possible sound levels.

Single, large-plenum fans and motors in custom cabinets were used for the original air-handling system. The six serving the performance hall were stacked top-and-bottom units because of the extra space required by the fans. Each one had to be cut out and removed in pieces as they were 6 to 9 m (20 to 30 ft) below building grade.

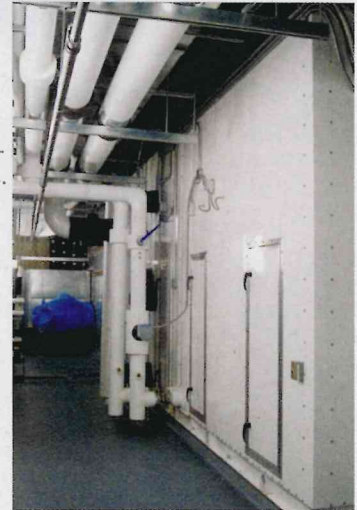
Right: The knock-down air-handler is compact enough to meet the space needs of a new flood-remediation scheme and quiet enough to measure up to the symphony hall's strict noise criteria.

The new AHUs had to be small enough to meet the space needs of a new flood-remediation scheme and quiet enough to measure up to the center's stringent noise criteria. Using a modular knock-down air-handler, the units were manufactured and assembled at the factory to ensure fit; they were then disassembled, labeled, and shipped to the site for reassembly.

Each cube-shaped cell houses a fan, motor, and electrical connections. The number and configuration of these compact cells depend on the airflow and static pressure requirements of the particular air-handling application. Custom systems were configured by selecting the number of fans, operating speed (revolutions per minute [rpm]), and wheel width and diameter. This allowed each design to be optimized for maximum efficiency.

The pieces were brought into the building through the grated air opening 6 m below grade and lowered using a crane. The modular cubes were moved individually into position without requiring any building damage and then stacked onsite into the appropriate configurations.

The vertical space gained by the new configuration will help the center deal with future flooding. The air-handling units with the new fans sit on structural steel platforms raised 1.8 m (6 ft) off the floor of the mechanical rooms. Turbine pumps installed in the spaces beneath the units will allow those areas to be used as sump pits in the event of a future flood.
